REPORT OF SANITARY SEWER OVERFLOW (SSO) INSPECTION

AT
The City of Bolivar, Missouri
345 S. Main Ave
P.O. Box 9
Bolivar, MO 65613

BY
U.S. ENVIRONMENTAL PROTECTION AGENCY
REGION VII

ON
SEPTEMBER 24, 25 AND 28, 2012

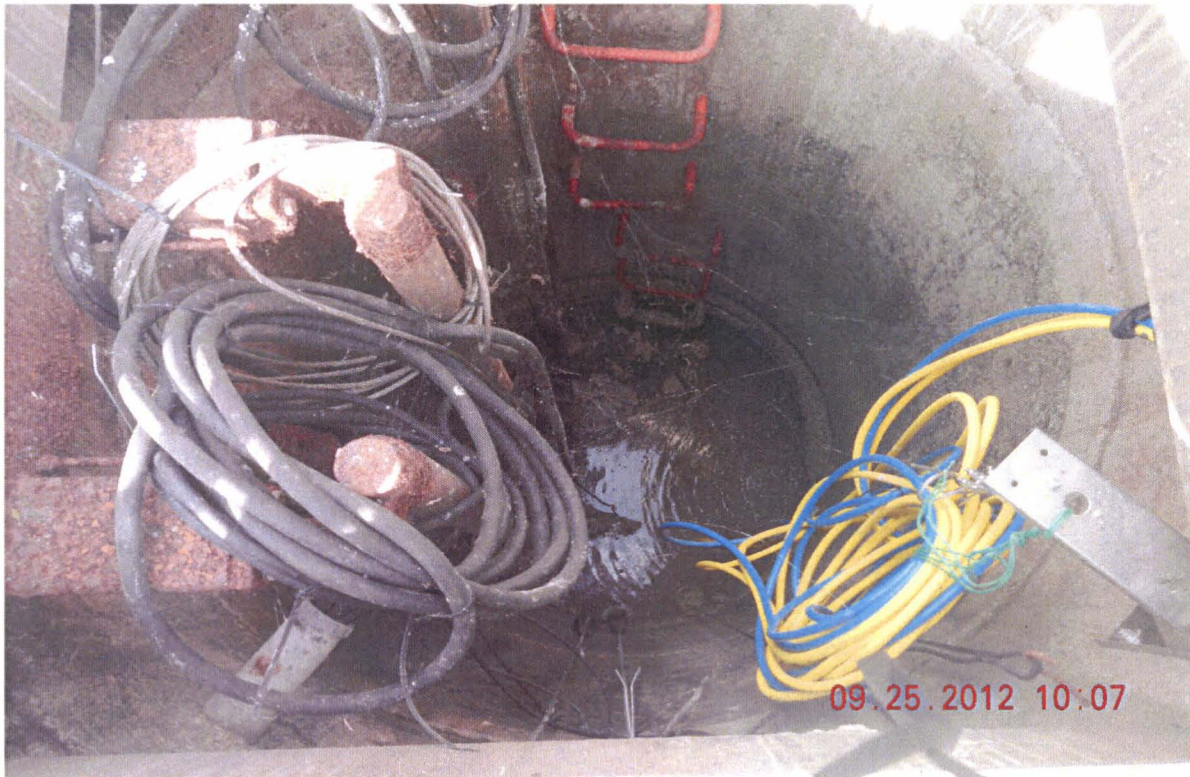
3. During my visual inspection of lift stations, I noticed the following issues:
 - a) Lift station #10 (DSCN0599-DSCN0606) has structural issues. The steel structure is rusted and it appeared to have been neglected for an extended period of time as shown in DSCN0604 below.

DSCN0604, Lift station #10 has structural issues.

- c) Lift stations #1 (DSCN0631-DSCN0637), #4 (DSCN0617-DSCN0621), #7 (DSCN0612-DSCN0616) and # 2 have significant grease accumulation. **Therefore, for items 2.a. 2.b. and 2.c., I issued Notice of Potential Violation (NOPV) #8 for the City's failure to properly clean, maintain, and provide sound structure to its lift stations.**

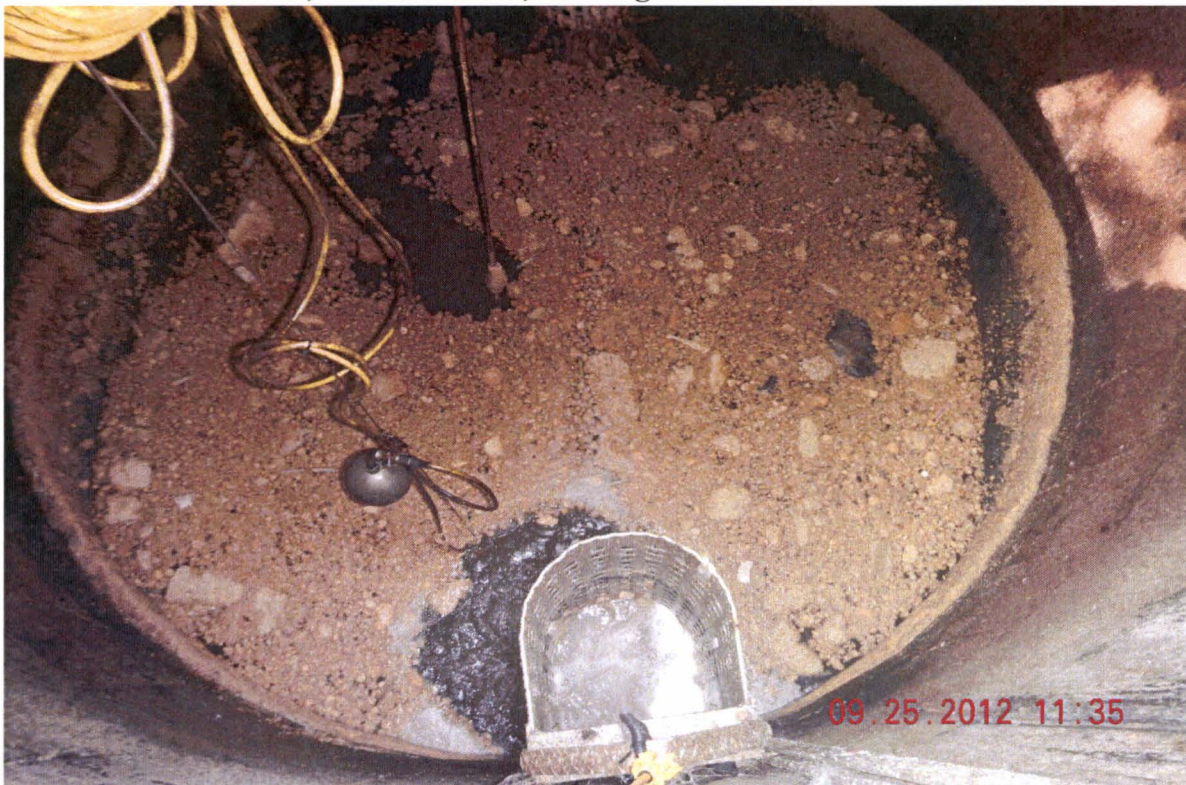
- b) Lift stations #1 (DSCN0631-DSCN0637), #4 (DSCN0617-DSCN0621), #7 (DSCN0612-DSCN0616) and # 2 have significant grease accumulation as shown in DSCN0634

DSCN0634, Lift station # 1, with Significant Grease Accumulation.

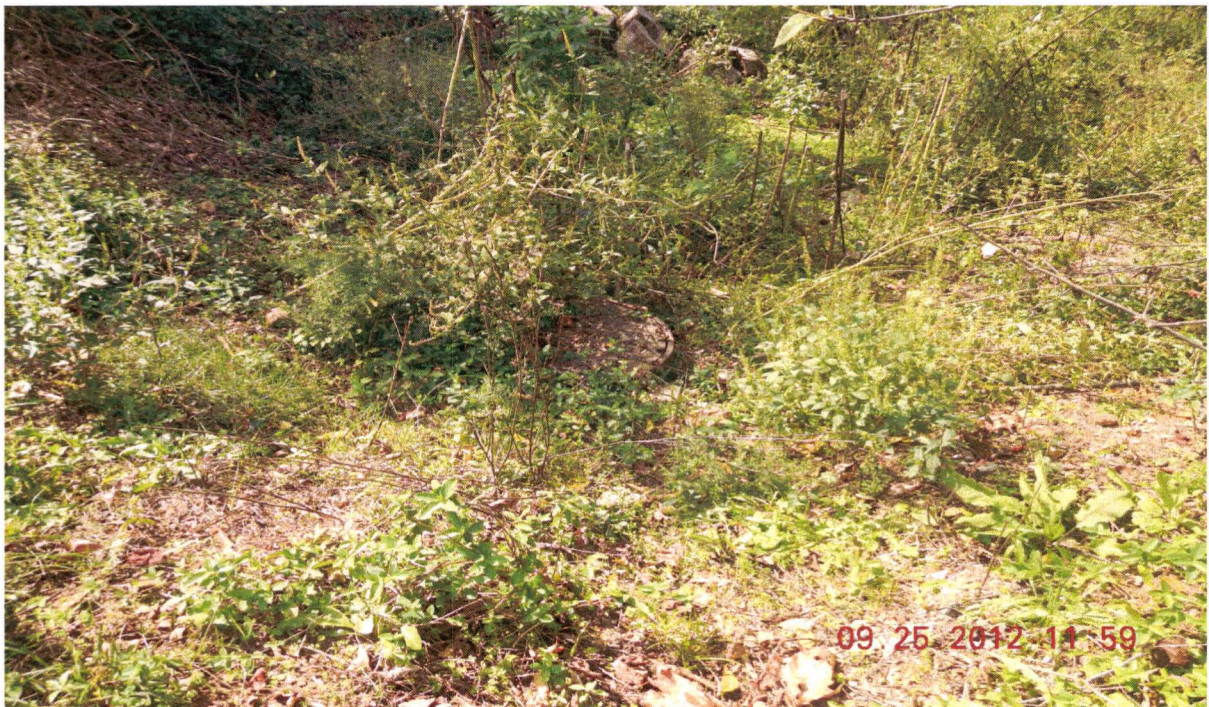
- f) During my visual inspection of lift station #5, I noticed that across the waterway there was a manhole that, according to Mr. Bradshaw and Mr. Allard, had overflows in the past during wet weather events (DSCN0644-DSCN0645). This manhole is located at the bottom of a small hill and it was below grade which is an ideal situation, during wet weather events, to receive inflow and infiltration from the lid as shown in DSCN0645 below.

DSCN0645, manhole near lift station #5, this manhole is at the bottom on the hill.

This manhole also was connected in series with another manhole which increases the flow coming in versus the flow going out significantly during wet weather (bottle necking). It appeared that the City knew about this specific location and its issues (and other locations with similar issues) but did not take the appropriate measures to correct it. **Therefore, I issued NOPV#10 for failure to adequately measure hydraulic capacity of such situations and take appropriate corrective measures to eliminate these issues.**
